### Inspection Report

#### Minerals Regulatory Program

**Mine Name:** Strawberry River  
**Operator or Permittee Name:**  
Rock-It Stone  
**Permittee Mailing Address:**  
P. O. Box 538, Heber City, Utah 84032

**Permit number:** S/013/008  
**Inspection Date:** August 13, 2004

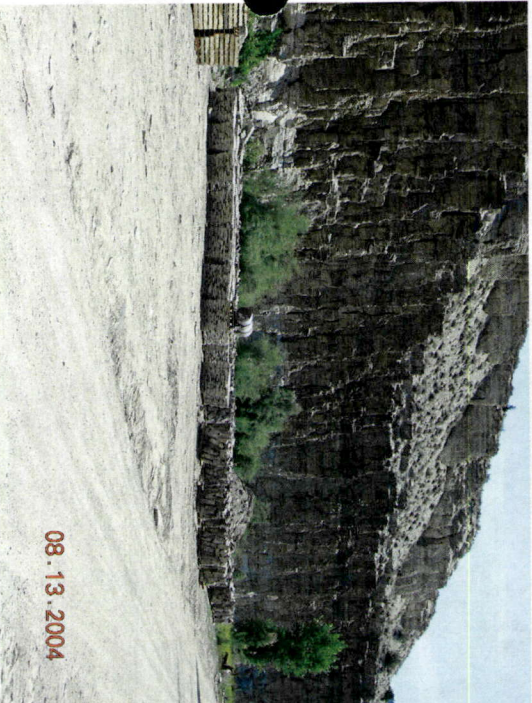
**Photo 1. Stone stockpiled next to the county road.**

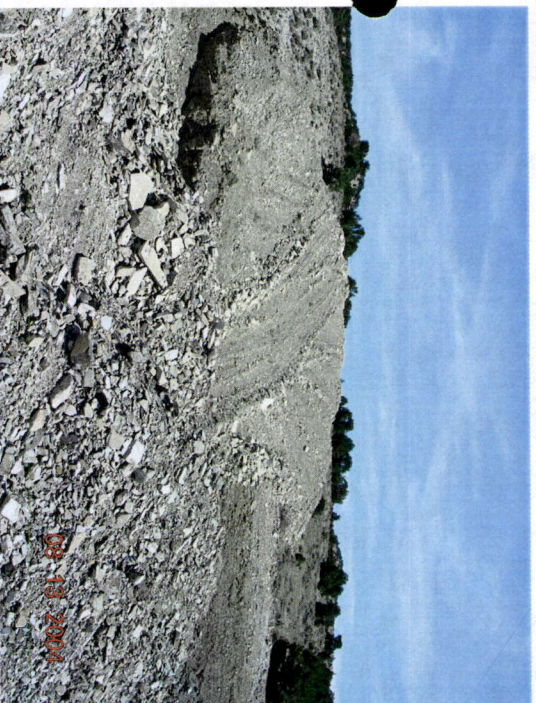
**Photo 2. The upper portion of the quarry.**

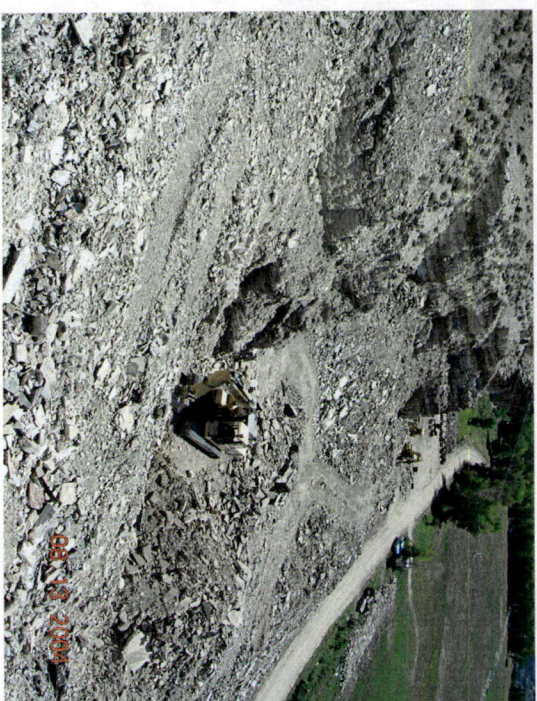
**Photo 3. View from the upper portion of the quarry toward the lower part of the quarry and the county road.**

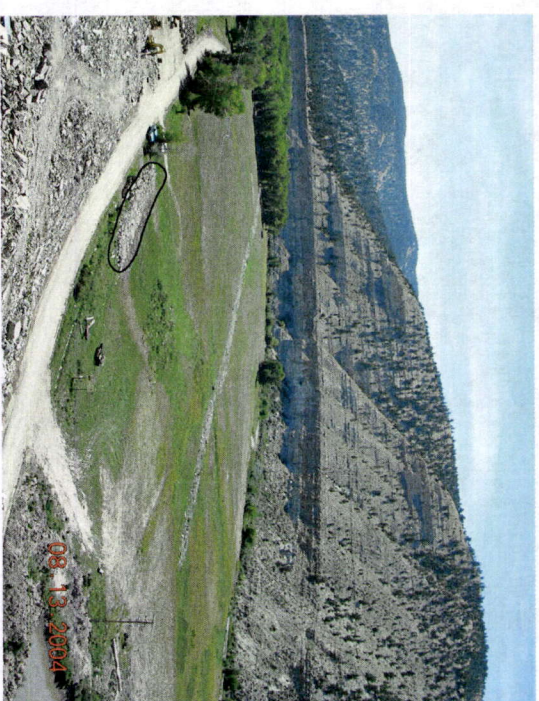
Photo 4 in the photo attachment shows a berm that is being built of waste rock across the road from the mine. It appeared the operator was disposing of waste material, but I later received a phone message from Bob Pinder, the owner of the land, who informed me that he has asked the operator to build the berm as part of some land development he is doing. For this reason, the waste rock berm is considered an end use, not waste disposal, and placement of the material on the south side of the road does not need to be permitted.

**Photo 4. The marked area is a berm being built with waste rock for the land owner/developer.**
